Crowsnest Pass Facility Evaluation Report

**Albert Stella Memorial Arena
12602 - 17 Avenue
Blairmore, Alberta**

**Architecture | Arndt Tkalcic Bengert
October , 2014**

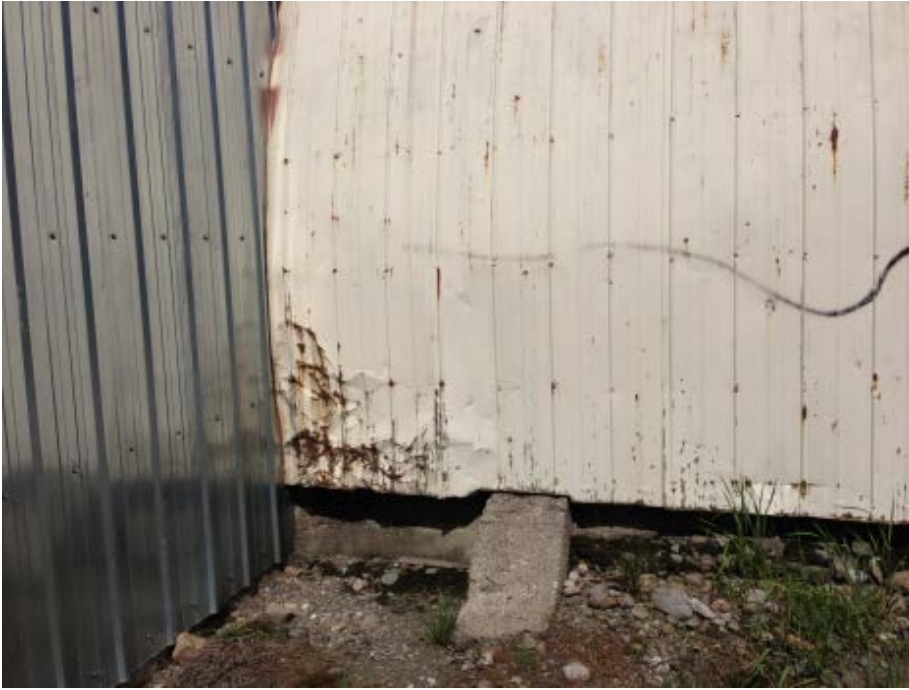
- .1 The debris around the site requires to be removed and landscaping around the immediate building requires to be regraded to allow positive drainage away from the foundation. The present site grading is causing moisture to collect round the foundation and could be compromising the structural foundations. The paved surface for parking and driving access to arena has deteriorated and requires repair and resurfacing. The pavement at the main entrance of the building does not appear to provide sufficient slope for spring runoff. At time of paving repairs a survey should be provided to insure the drainage and water management is adequate. The gravel fire lane access provided around the buildings requires regrading for proper drainage. A swale should be created around the outside of the gravel lane to control the spring run-off from the adjacent mountain. (Refer to Photos C1, C2, C3 and C4)

C1- Regrading is required around the building to provide proper drainage

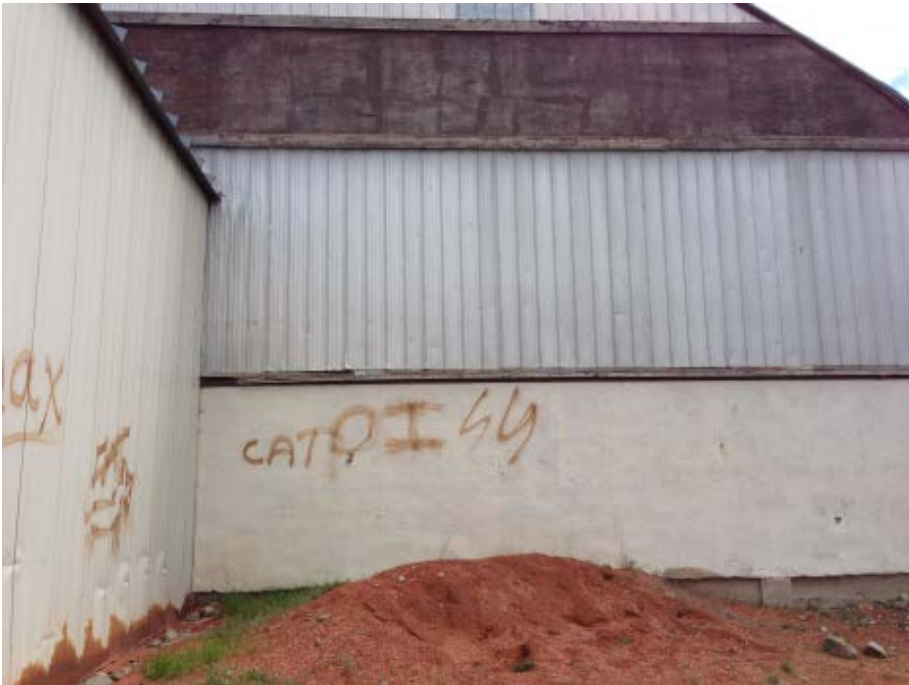
C2- Remove debris and materials from around the building to improve drainage.

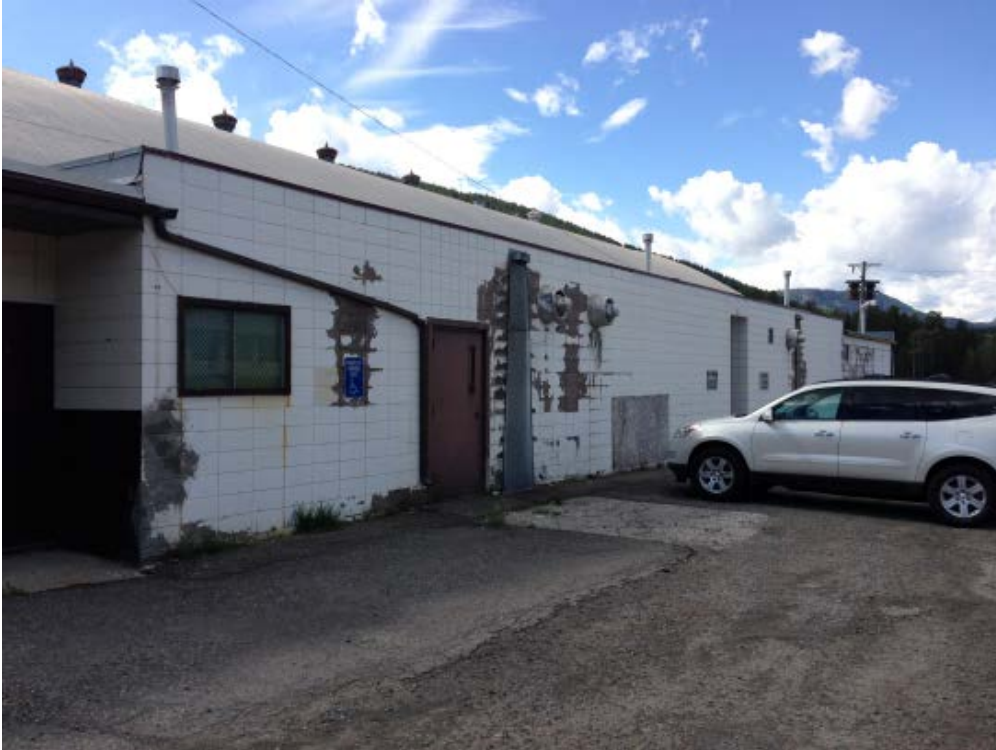
C3 - Paving requires to be replaced and regrading

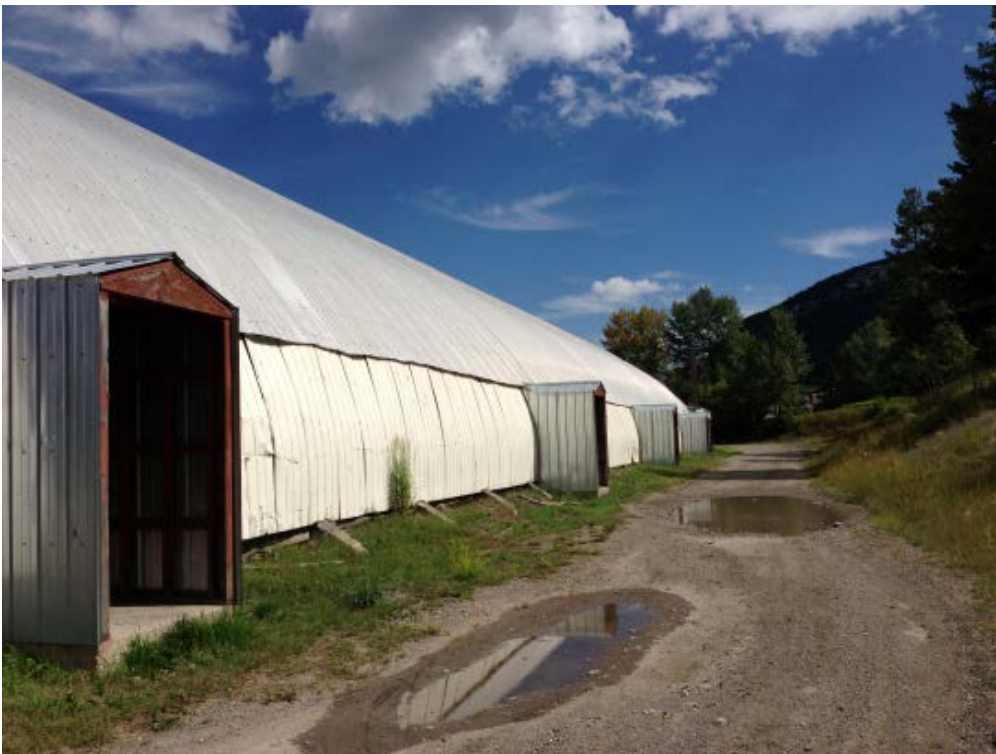
C4 - Fire lane access requires regrading and a swale to keep spring runoff from Mountain away from the building foundation

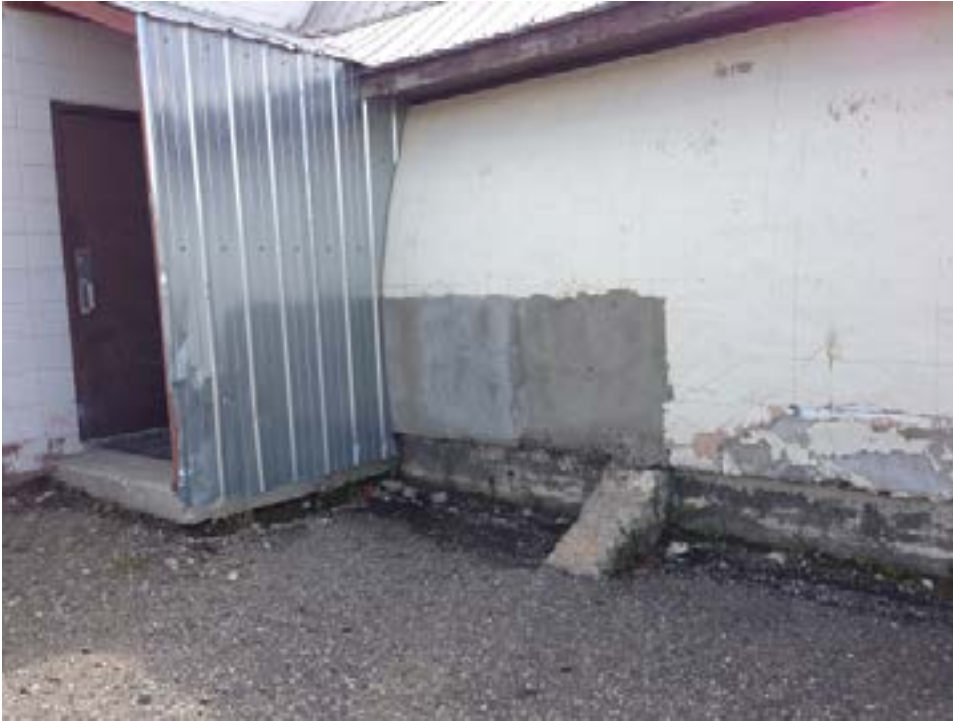
The exterior envelope materials of the building for this facility are primarily metal ribbed roofing and siding, load bearing concrete block, stucco, and painted wood fascia. All finishes to the facility are in critical condition and require complete replacement. (Refer to Photos A1, A2, A3, A4, and A5)

A1 exterior wall and roof envelope requires replacement

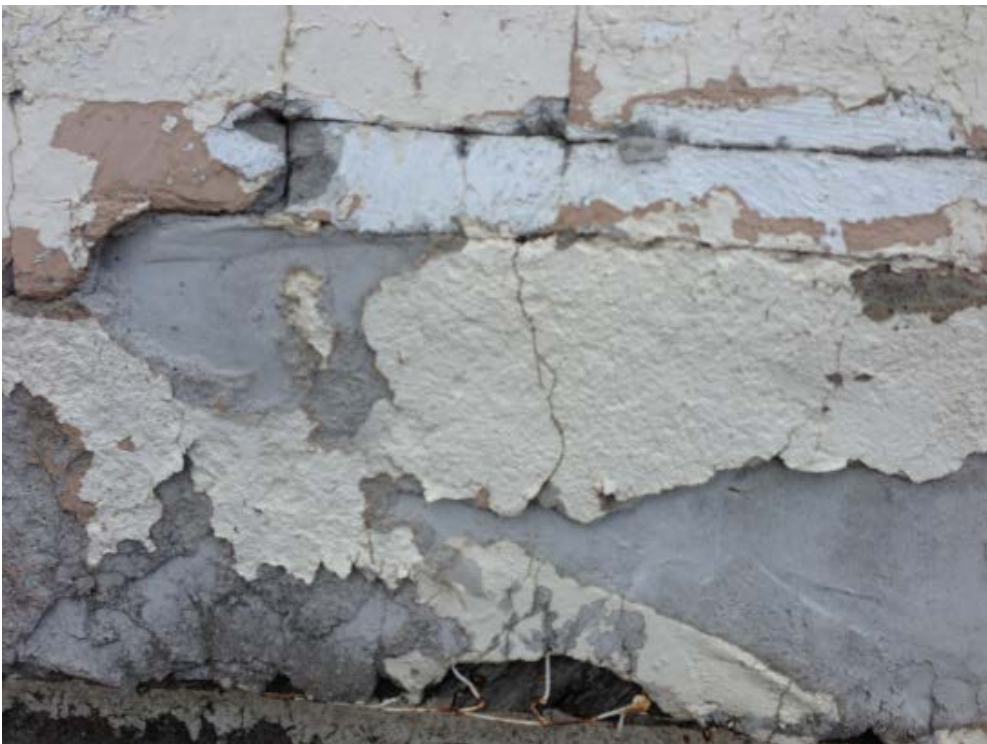
A2 exterior wall requires replacement

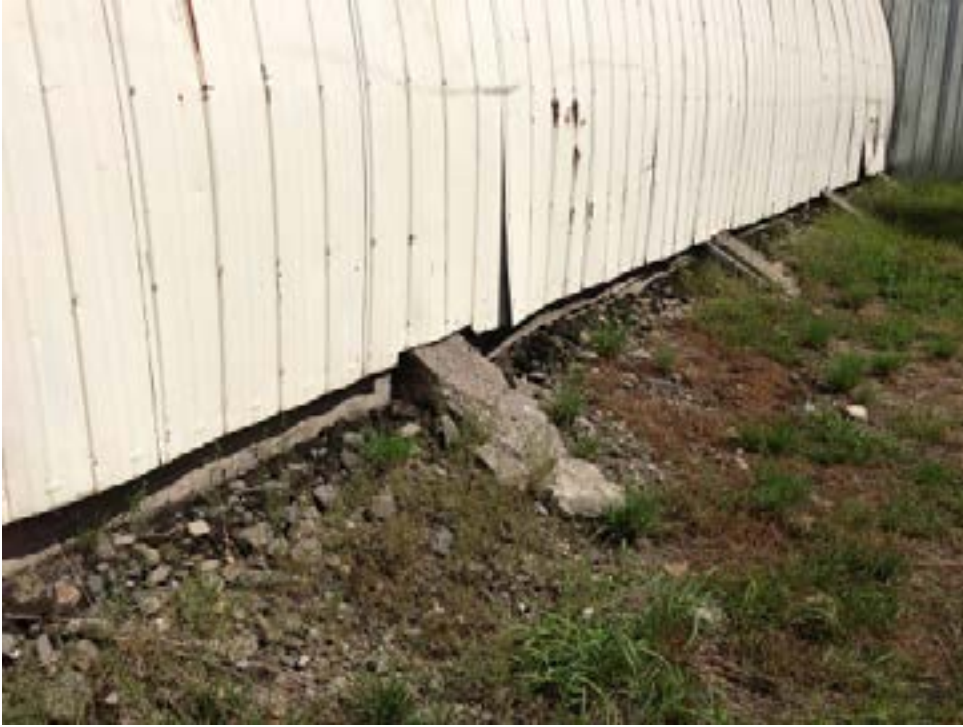
The concrete buttress structural foundation support appear to be damaged and should be repaired to maintain the structural integrity of the building. The wood roof structures are showing signs of damage due to water infiltration. The mechanical roof structure has been shored up recently as the structure was failing. The load bearing concrete block supporting the steel roof structure is showing deterioration and requires to be protected from freeze thaw cycles and moisture inside the showers. Further investigation is required to ensure the structural integrity of all structures have not deteriorated. (Refer to Photos S1, S2, and S3)

A3/S1 structural buttress supports are damaged

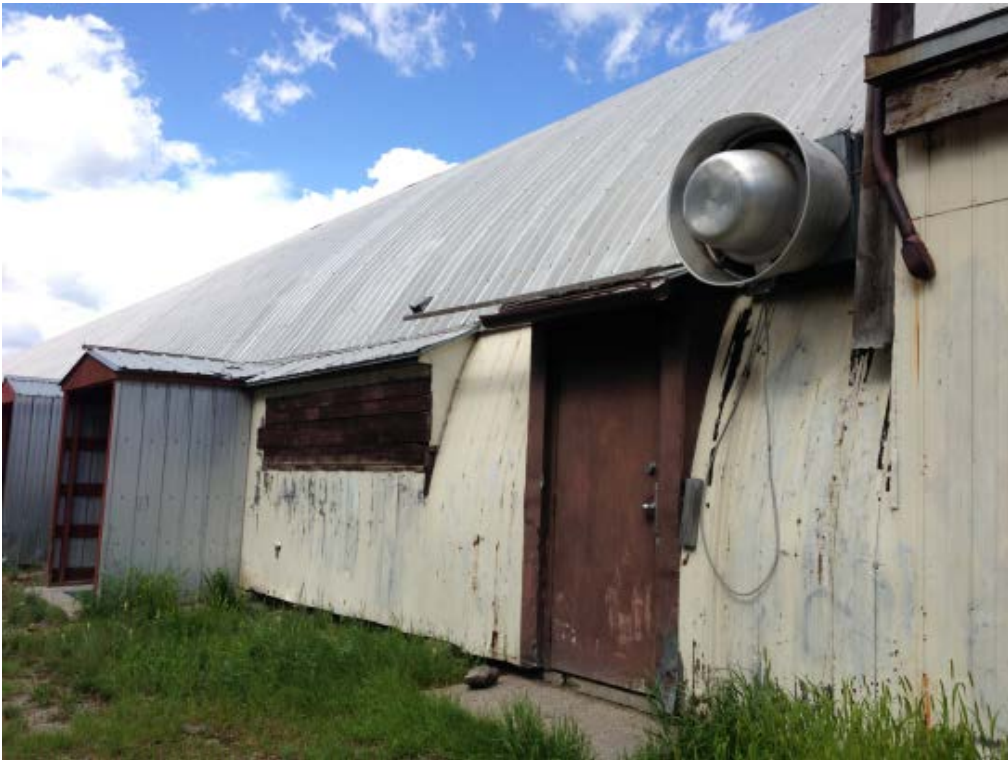
A4- Envelope deficiencies

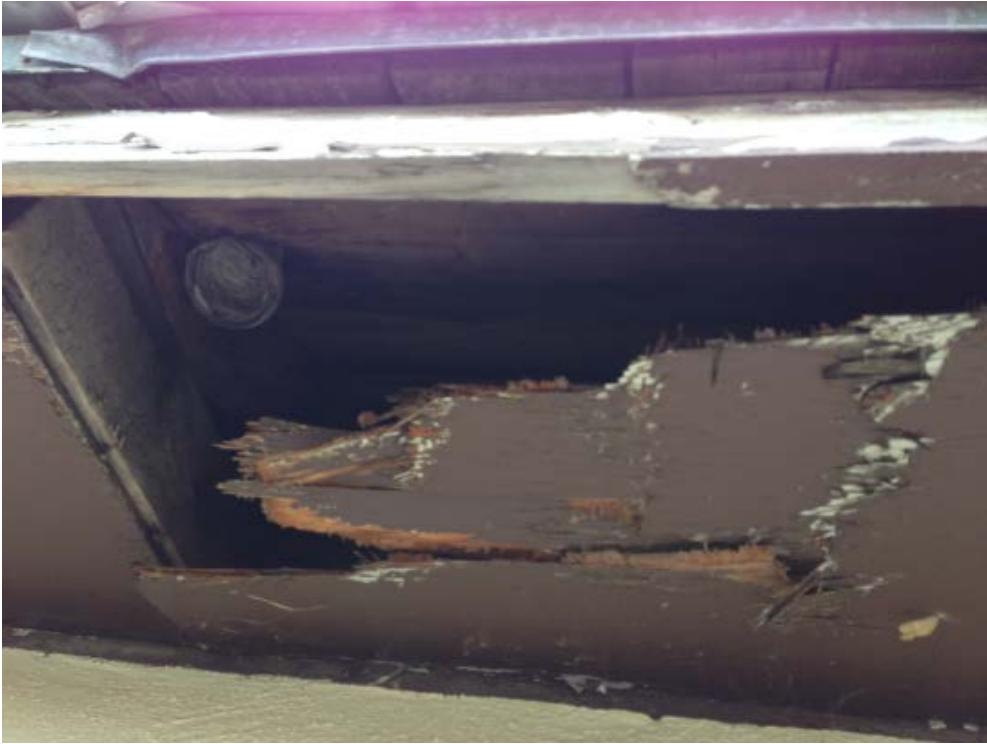
A5- soffit deficiencies

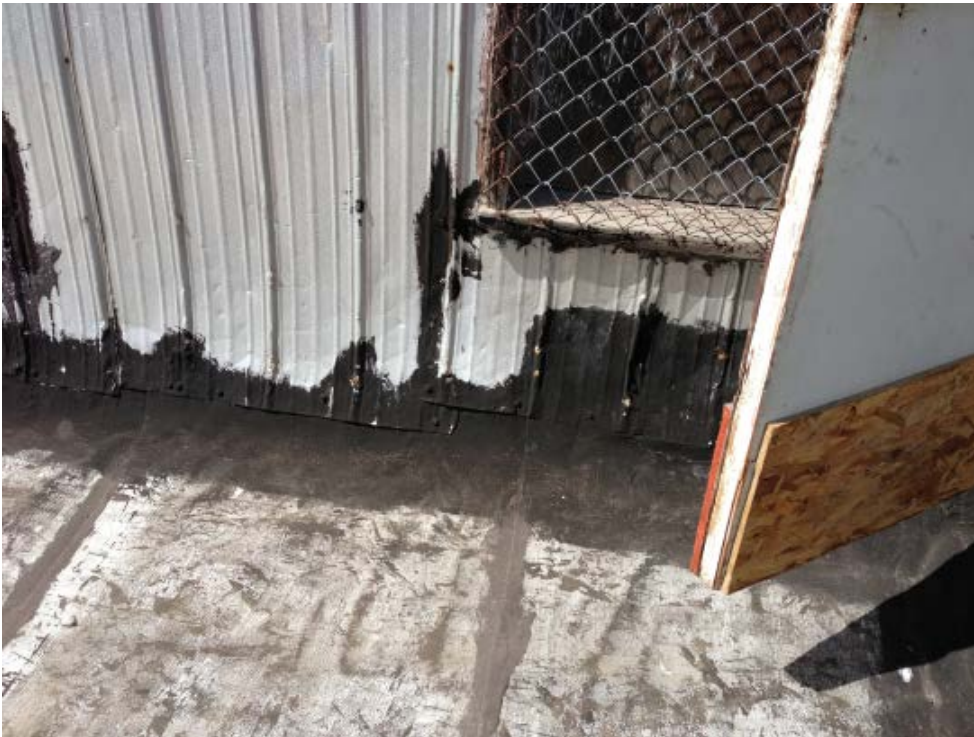
There is a small area of low sloped roof over the mechanical room which has a membrane roofing over an insulated wood structure, this roof has been leaking and some temporary patching has been completed without proper lapping of flashings. The roof has extensive moisture trapped inside the cavity and mould is present. This area requires immediate attention to remove the mould and the

entire roof structure must be replaced. Further investigation is required to review the extent of the damage and mould and provide direction for proper removal. (Refer to Photos A6, A7, and A8)

A6- Improper roof and wall flashing are allowing water infiltration

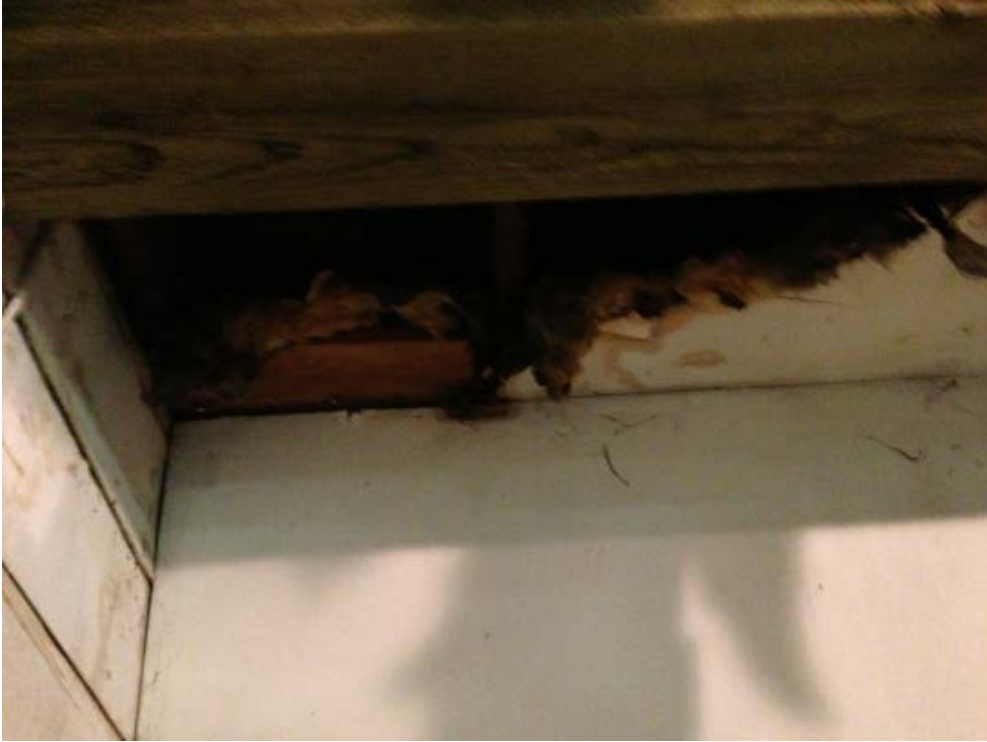
A7 - Roof taking on moisture

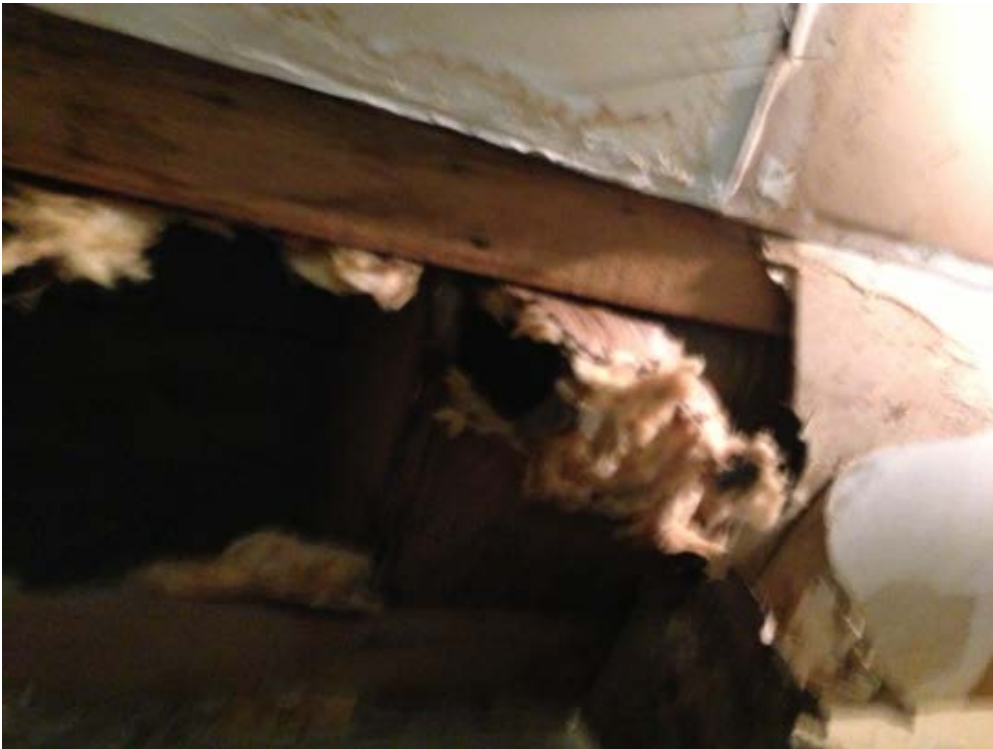
A8 - Roof requires removal and repair

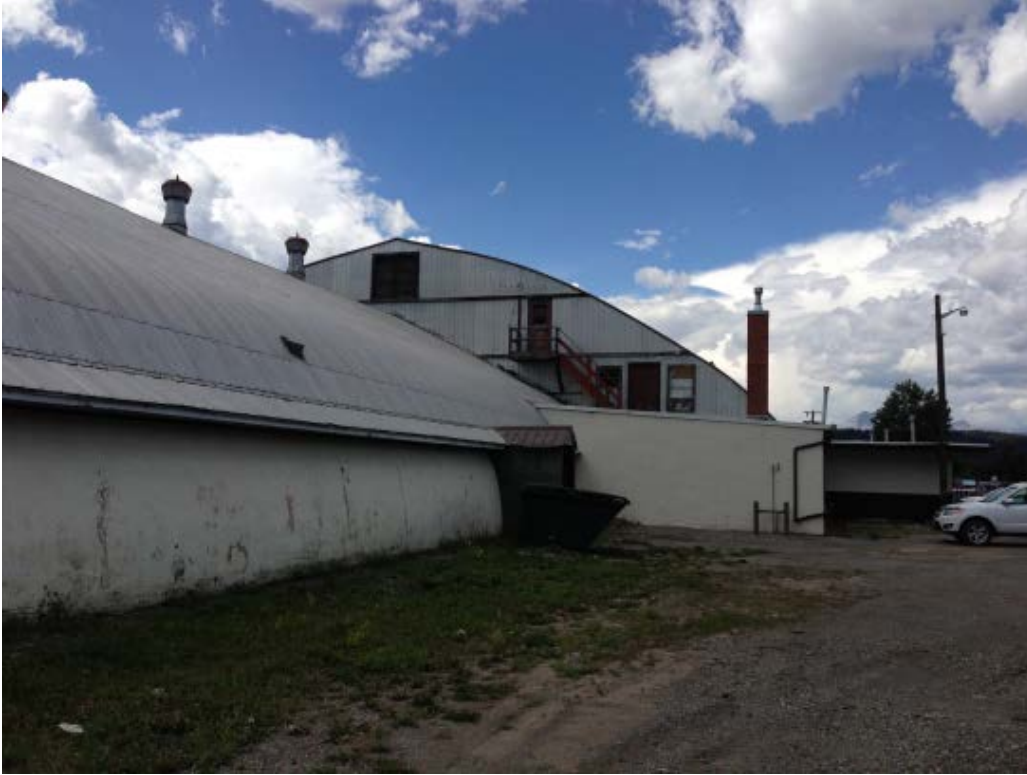
Collection of water and control of snow falling from the building is poor. Snow fencing and a gutter system would improve the drainage and mitigate the freeze thaw cycles and foundation deterioration. (Refer to Photos A9, and A10).

A9 - snow fence and eavestroughing required control water and snow

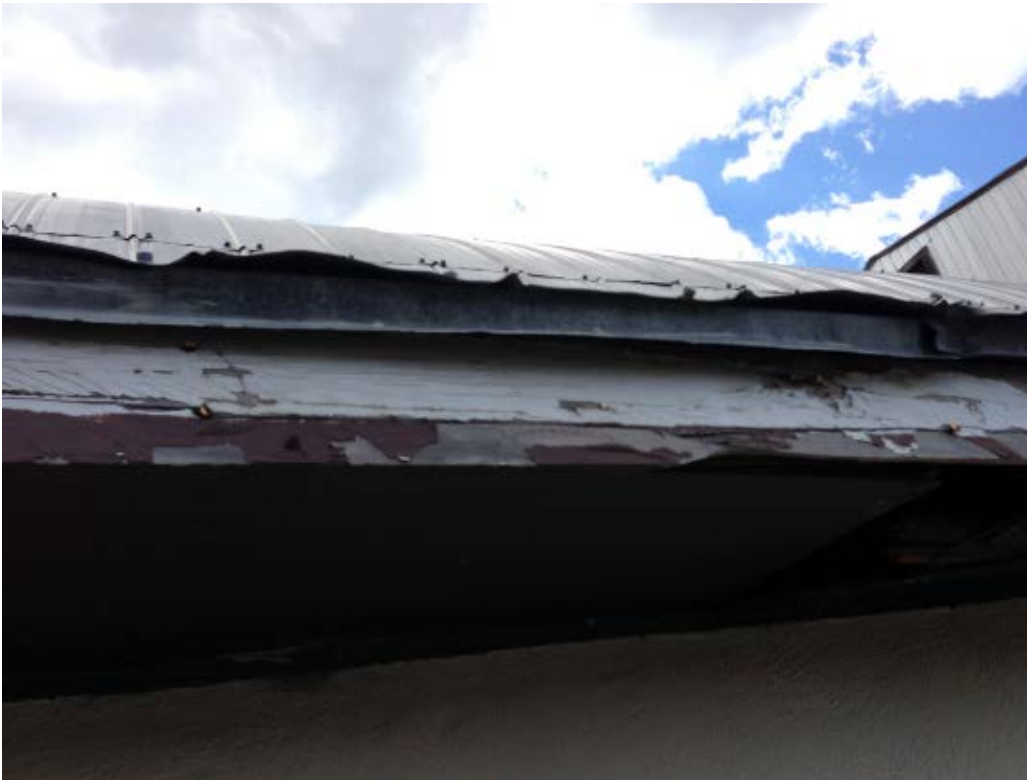
A10- Eavestroughing required control water and snow

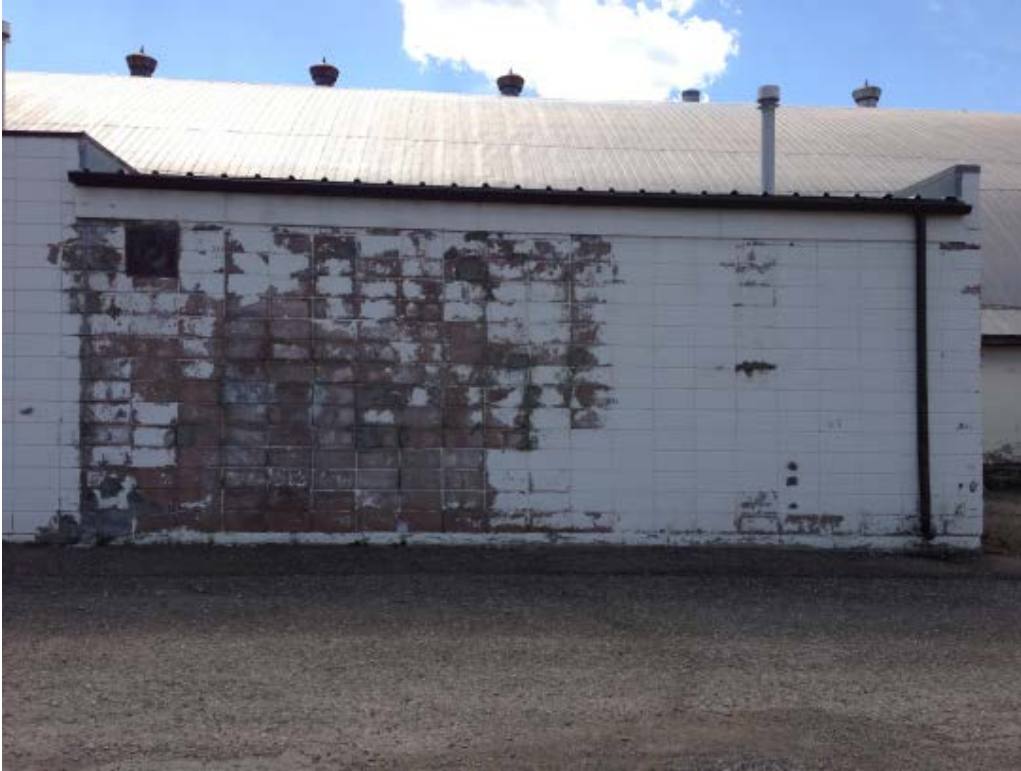
The building envelope protection at the base of the wall has seriously deteriorated. Existing materials require removal and replacement with proper membranes and a durable abuse resistant base to protect the building structure from moisture and further structural damage. Soffits and roof materials are damaged and require replacement (Refer to Photos A11, A12, and A13).

A11- Load bearing block wall damage

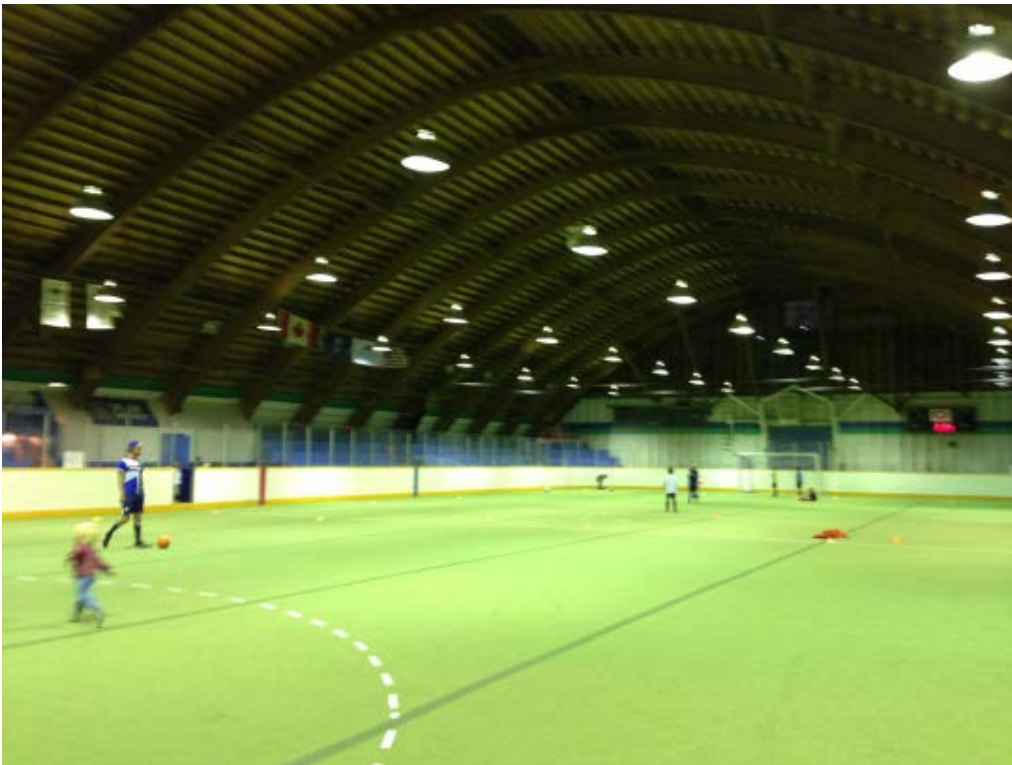
Finishes within the facility are primarily painted wood material and are very tired and dated. The skate tile flooring is damaged throughout and should be replaced with an appropriate flooring as this facility is not used for ice skating. The main arena/soccer pitch has an indoor/outdoor turf that is extremely worn and should be replaced. There are many tripping hazards through the facility due to uneven flooring and deterioration.

A12- Indoor soccer pitch turf

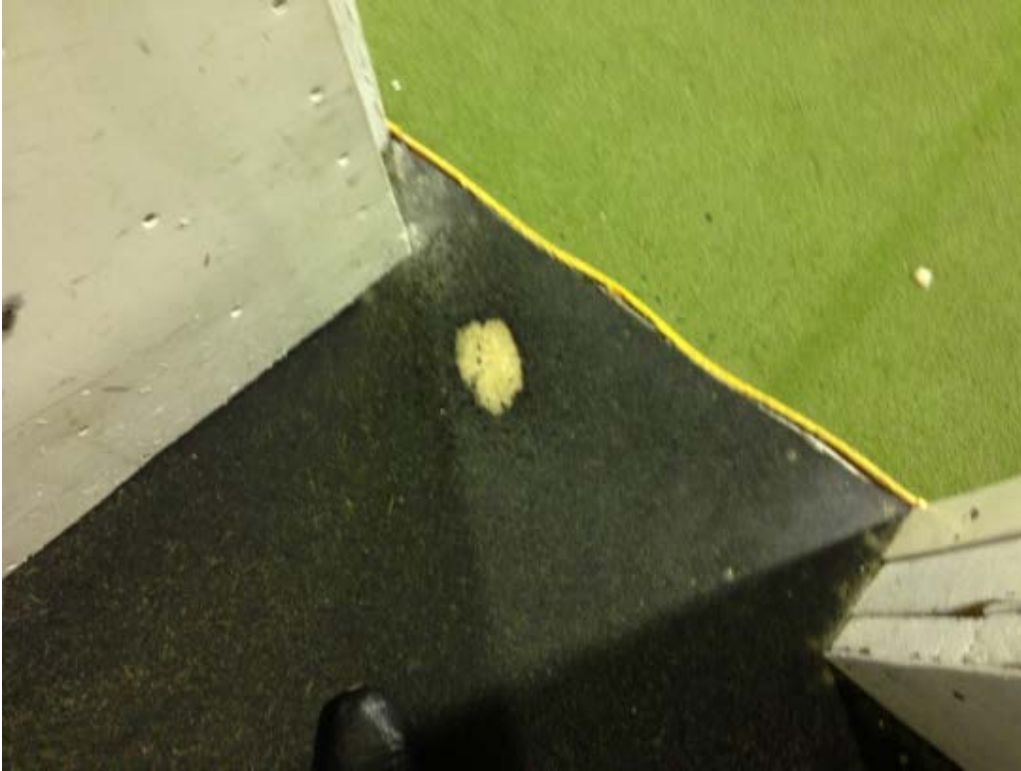
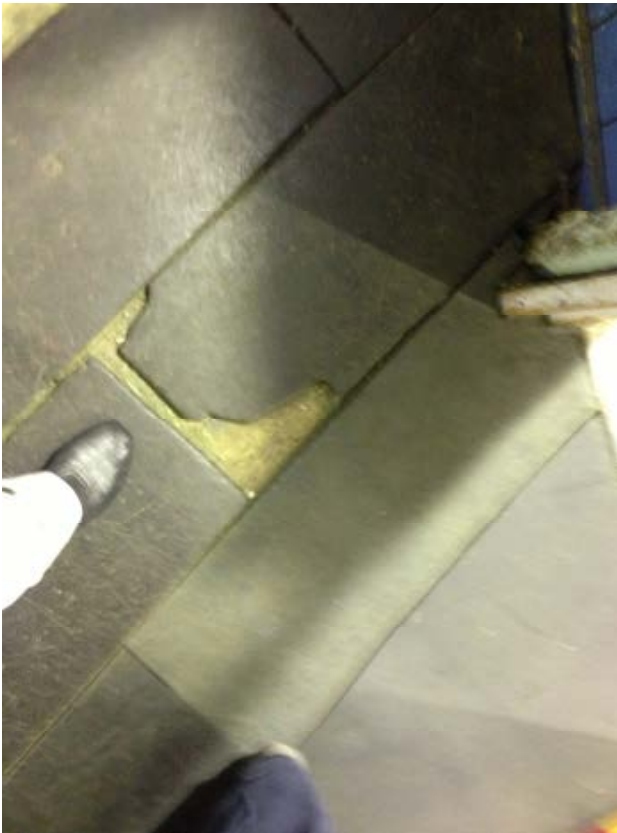
A13and 14 - Indoor skate tile is worn and requires replacement

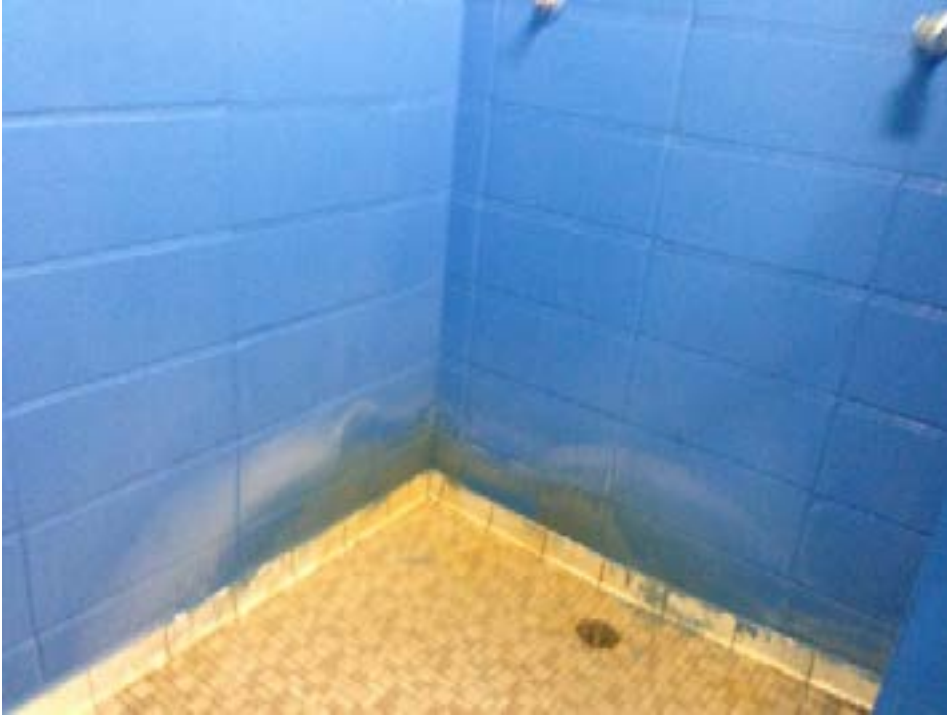
The change room addition from 1991 has concrete block walls and steel roof structure. The washroom and shower facilities require tile at the showers and urinals by code. The block walls appear damaged from the moisture in the showers as these are load bearing concrete block and the block is exposed to the exterior without a moisture barrier or insulation protection. Further investigation is required to determine if the block walls at the shower areas have deteriorated structurally. New ceramic floor and wall tile should be provided in the change room washroom areas. (Refer to Photo A-15)

A15 - Change room shower floor tile and concrete block walls are showing damage from moisture infiltration to loadbearing block

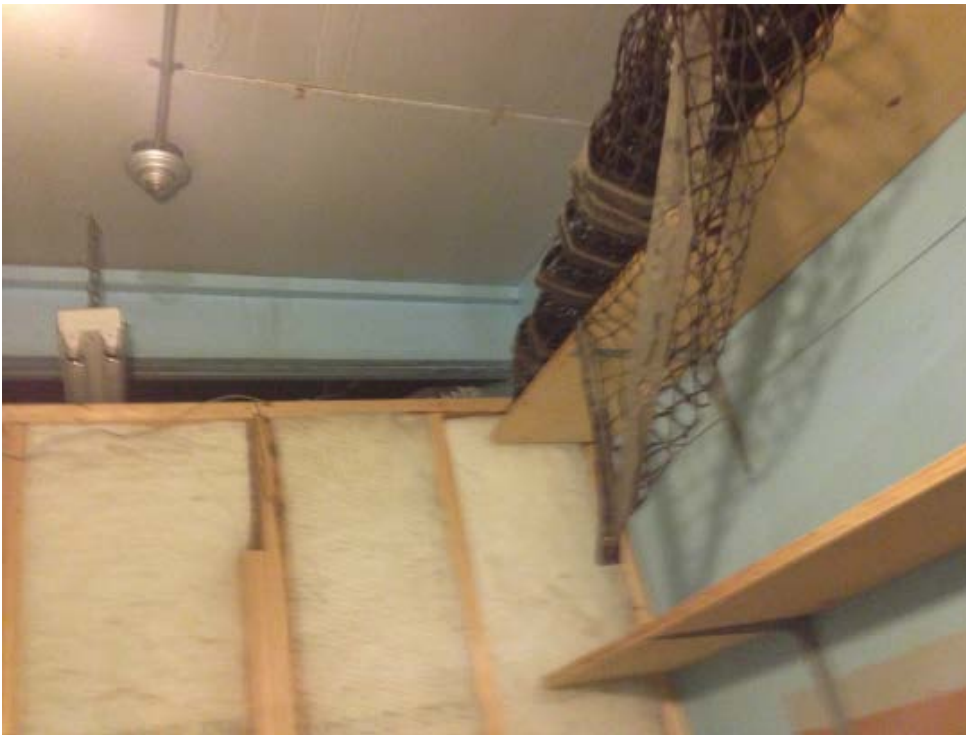
There are many building code infractions in the facility. Storage rooms are not fire separated, the wood floor and supporting structures above the main floor require to be fire rated. The client identified that the indoor skateboard park equipment is not CSA approved and requires replacement. Janitor rooms, Mechanical rooms and Electrical rooms are required to be fire rated and should not be located under exit stairs. All of these building code violations were observed on site and require to be fixed by providing fire rated wall and ceiling separations and fire rated doors. (Refer to Photo A-16)

A16 - Fire rating for storage room and electrical room walls are not provided

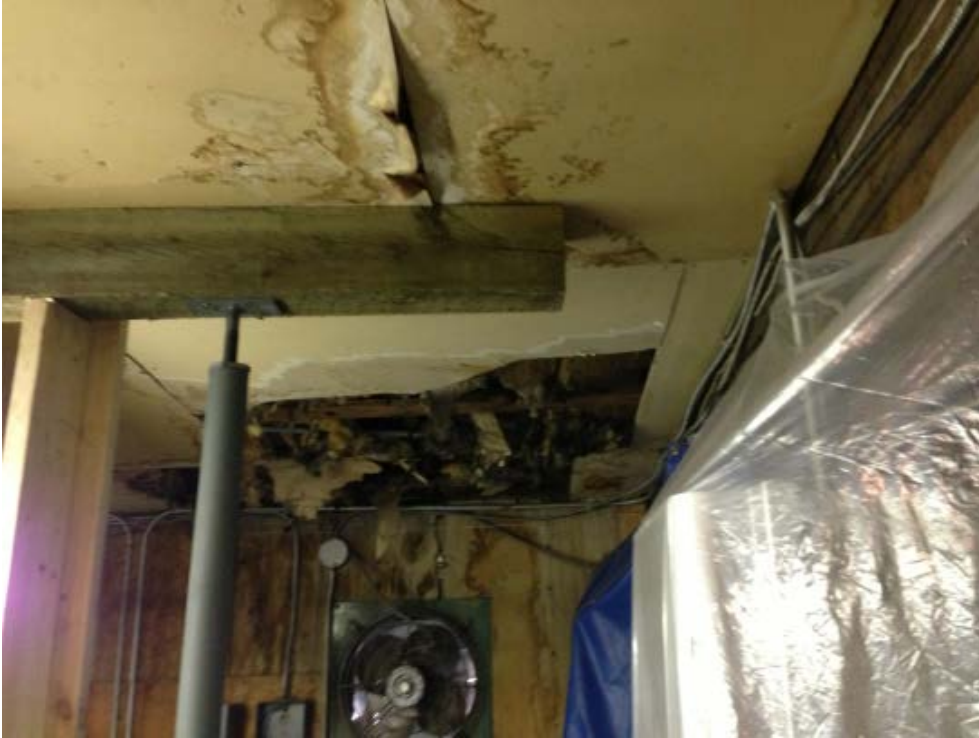
S2 - Shoring of failed roof due to moisture intake and subsequent presences of mould.

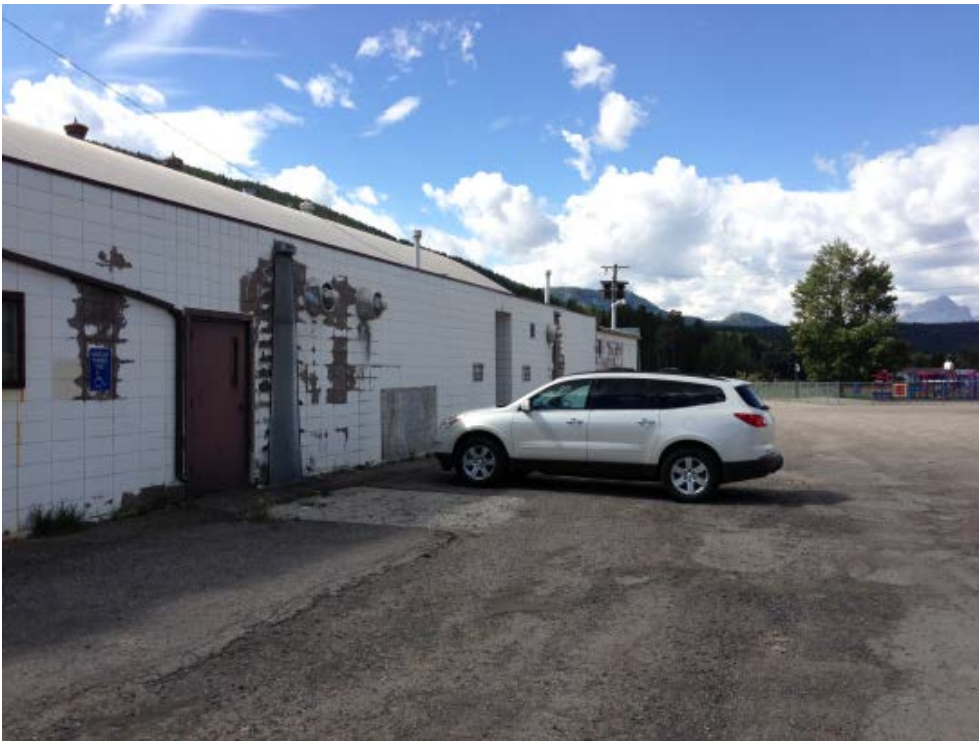
S3 - Deterioration of concrete block exposed to freeze thaw cycles and excessive moisture from locker room showers.

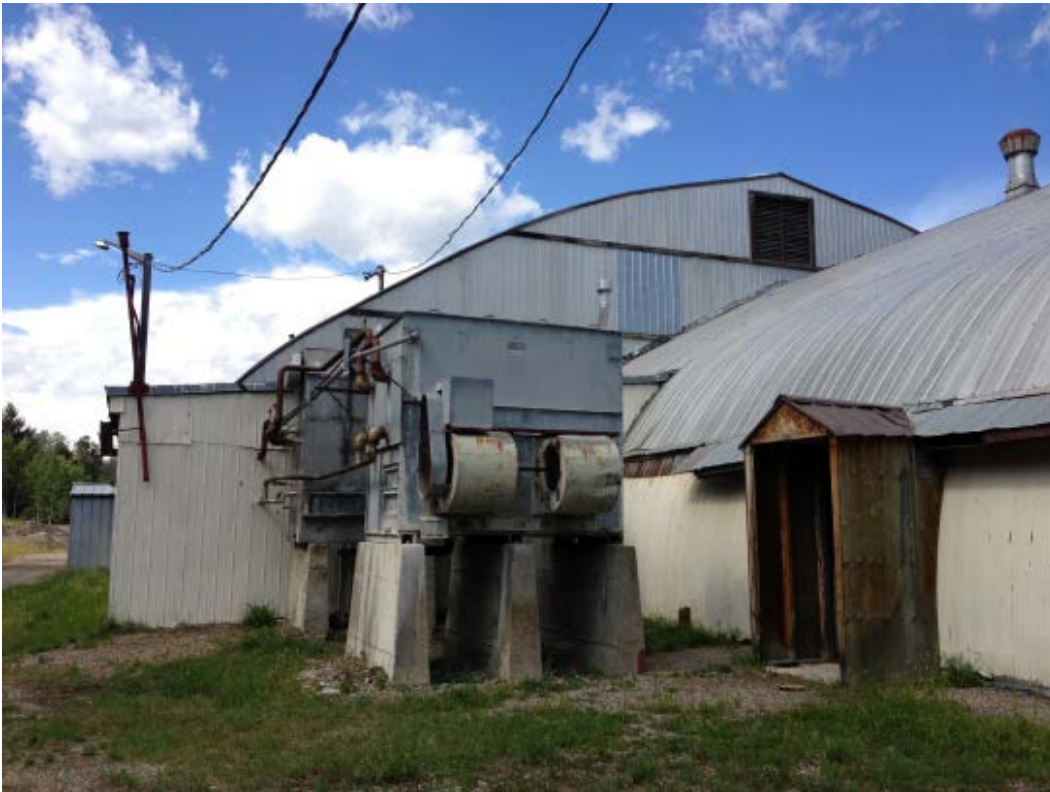
M2 - Original Ice plant system require to be removed.

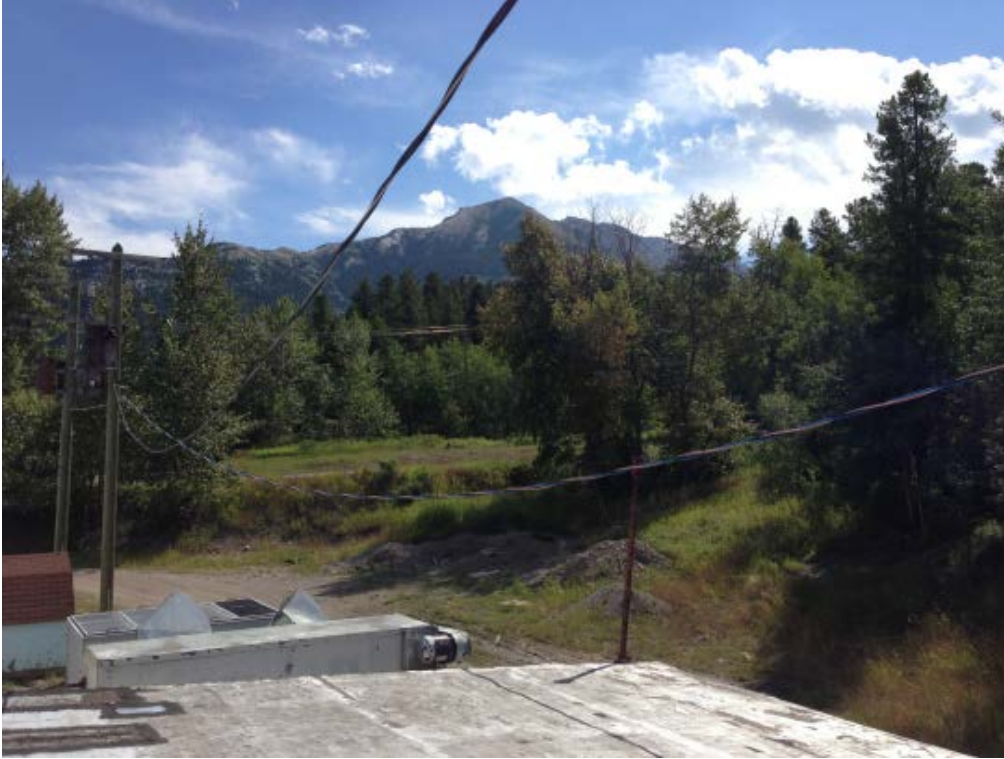
E1 - Live wires are accessible to the roof access

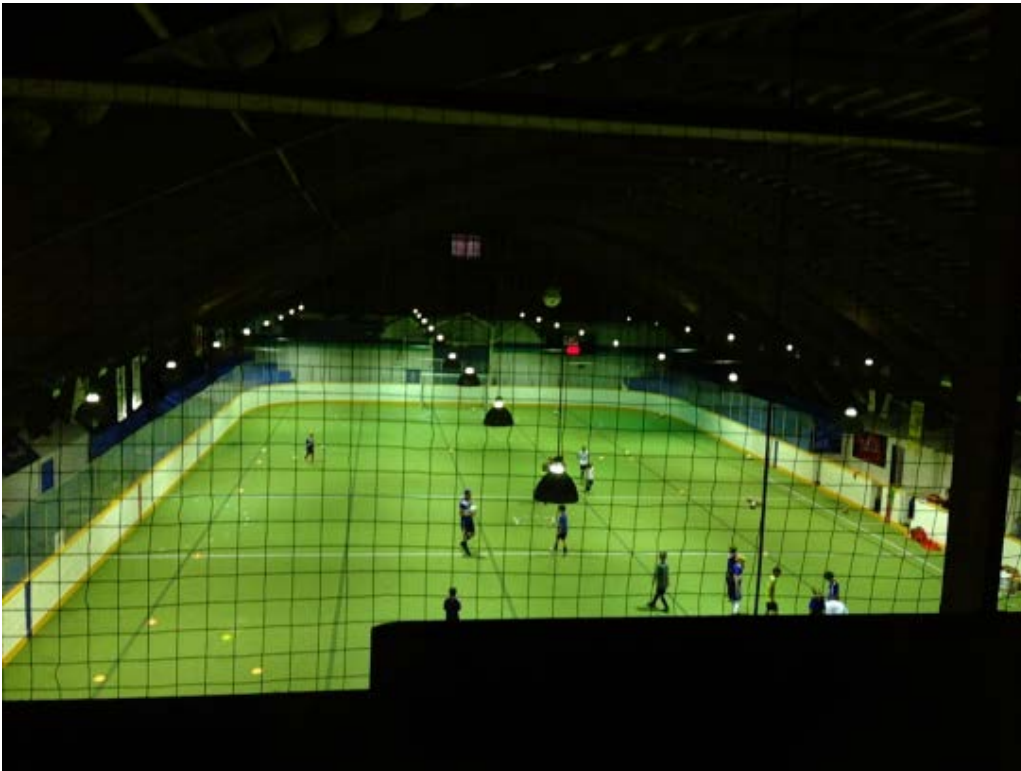
E2- existing lighting levels are very low and fixtures require replacement.
