MUNICIPALITY OF CROWSNEST PASS

Coleman and Area

Community Design Strategies Inc.

HERITAGE INVENTORY PROJECT – PHASE 1

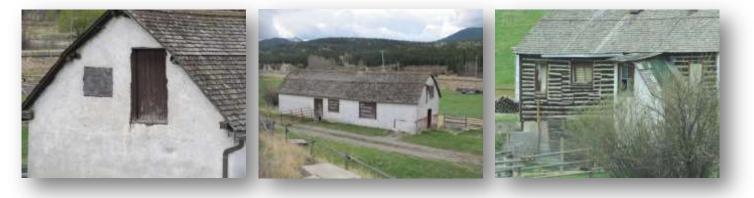
LOG BARN 8637 16 AVENUE Coleman, Alberta

The Log Barn is an open, post-and-beam, horizontal log structure clad with white stucco. It has a gambrel rood with roof shakes, projecting wood eaves, and verges with exposed wood purlins. The window openings have wood lug sills, and the sides have upper-storey doors. The structure is situated on the downside hill south of Highway 3, with a stuccoed one-storey exposed on the front façade and exposed log two-storey exposed on the rear.

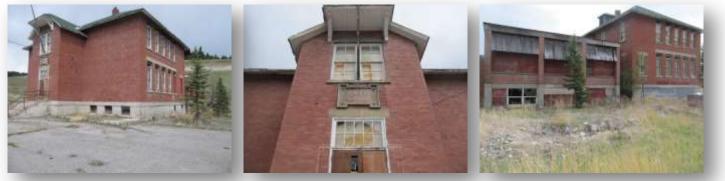
CAMERON SCHOOL

The Cameron School is a large, 1919, two-storey brick structure on a partially raised cement basement built on a square plan. It has a hip roof. The entrance is through a square tower projecting from the south façade void of any windows. The school is located on four town lots in West Coleman south of Highway 3, with older residential development on the other three sides.

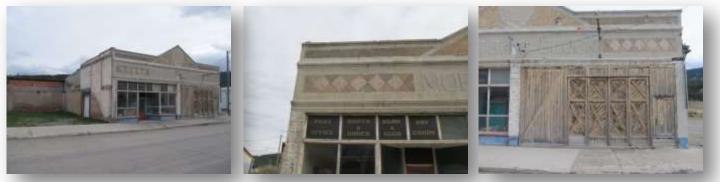
MORRISON BLOCK

The Morrison Block is a 1912, one-storey, stucco, Moderne-influenced structure with a boomtown facade. The facade incorporates a traditional raked entry, transom windows with product lettering, large multi-lite display windows, bulkhead, an upper signband area with a diamond stucco pattern and raised "Morrison Block" letters, and a pointed upper pediment with a decorated stucco pattern. The original breezeway giving access to a gas pump is enclosed. The building is situated near the west end of the main commercial street.

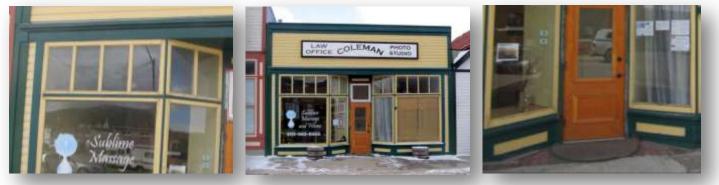
McBURNEY DRUG STORE

The McBurney Drug Store is a c1920, rectangular, one-storey, wood-frame, Boomtown-style commercial building has a central recessed, raked-entry flanked by large display windows that have multi-light transoms above, and small wood paneled bulkheads below. The building is positioned on a single town lot between two early commercial structures of the same period, and abuts the public sidewalk along the main street of downtown Coleman.

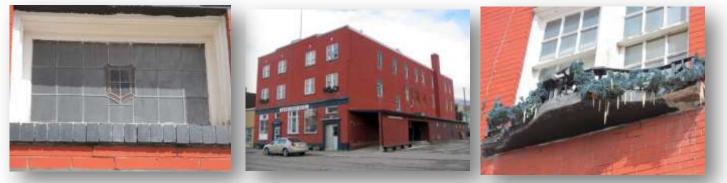
GRAND UNION HOTEL 7719 17 AVENUE

The Grand Union Hotel is a 1924, three-storey, brick structure with a stepped parapet, a central flagpole, and four concrete medallions just above the third-storey windows. A black concrete band is positioned at the base of the façade and ties into the concrete moulded head shelves and side trim of two entrance doors. A similar upper, black-painted, concrete mid-cornice band runs horizontally above the main floor window openings that include a series of leaded stained glass windows. A series of single-hung wood windows, with single or multi-pane lights are throughout all sides and the front facade, of which also carries two metal balconets on two second-storey windows.

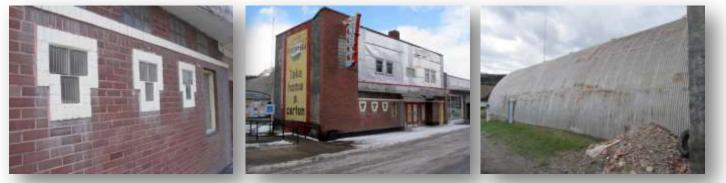
ROXY THEATRE

The Roxy Theatre is a 1948, two-storey, wooden structure attached to a large Quonset at the rear. A mixture of brick and aluminum finishes on the front façade form an L-shaped massing with fluted galvanized panels above a triangular fixed-canopy above and slightly recessed entrance. A number of glass block inserts decorate the façade, and a neon "Roxy" sign projects from the brick tower on the left. A Pepsi ghost mural exists on the left side of the main structure. The theatre is situated on the main commercial street of downtown Coleman, and abuts the public sidewalk.

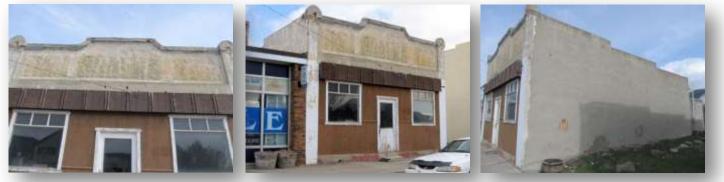
JANOSTAK GROCERY

Janostak Grocery is a c1925, early-commercial, one-storey, hollow red-clay block structure with a stuccoed uppermoulded stepped-parapet, and sign band area flanked by pilasters with round terminations projecting above the parapet. The building has flush-entry with original fixed display windows and multi-light transoms. The building is located within the central commercial district and abuts a public sidewalk.

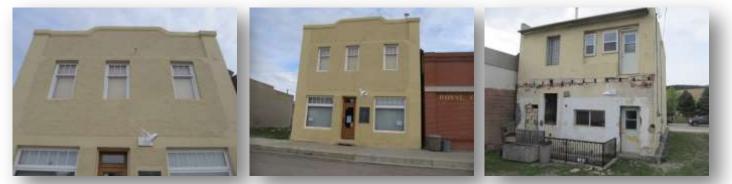
7819 17 AVENUE Coleman, Alberta

The Salvation Army building is a c1920s, two-storey, hollow red-clay block structure with decorative coarse and smooth stucco detailing, a stepped parapet, and an upper inset flanked by pilasters. The lower flush façade has a central inset with a two-panel wood door flanked by fixed display windows with multi-light transoms. The second-storey has three, three-over-one, single-hung wood. The building is located on single town lot in downtown Coleman, and abuts the public sidewalk.

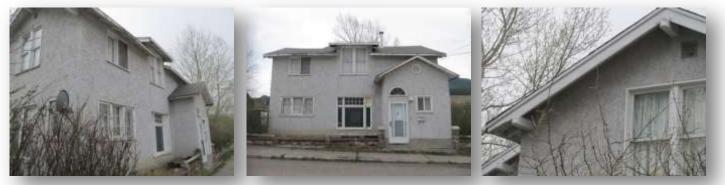
7486 18 AVENUE Coleman, Alberta

The John D'Appolonia Residence is a simple 1930 long rectangular, two-storey, wood-frame building with a low-gable roof, a central shed dormer, and a one-storey, enclosed front porch on the end of the front façade. The eaves contain exposed rafters and exposed purlins bracket the side verges. The residence is set on large grassed and treed town lot, with a solid brick wall across the front of the lot, and abuts the public sidewalk.

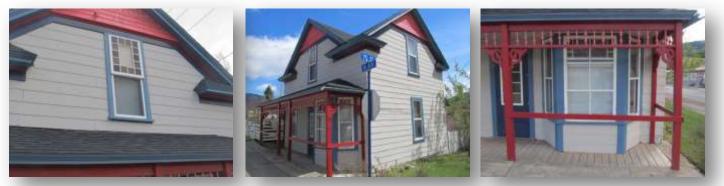
7502 18 AVENUE Coleman, Alberta

The Wes Johnston Residence is a 1908 rectangular, one-and-a-half storey, wood-frame building with a medium-gable roof and a central gabled dormer contained on the front facade. The verges contain a shingle detail and returned eaves. An open verandah consists of simple square posts, open rail, decorated brackets and a triellage. The main residence has a rear wing built in c1908 that follows similar details as the main residence. The structure is situated on a corner lot just west of Coleman's main street.

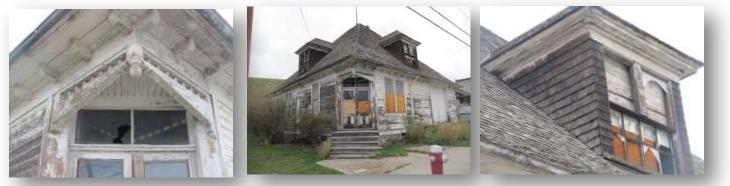
7601 18 AVENUE Coleman, Alberta

The Coleman Coal and Coke Mine Office is a 1904 one-and-a-half storey, wood-frame, shiplap-sided structure on a square plan, located one block north of the main commercial downtown district. It has an unusual steeply-pitched, bellcast hipped roof with hip dormers on the west, east and south elevations, and decorative soffit brackets along the underside of the eaves.

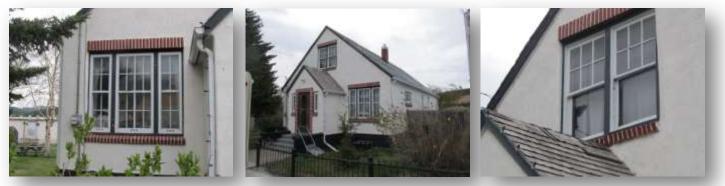
DOCTOR'S RESIDENCE

The Doctor's Residence is a simple 1939 rectangular, one-and-a-half storey, wood-frame, stuccoed building with a high-gable roof, and an enclosed front porch on the front façade. The windows carry brick head detailing and an angled brick sill. The eaves provide a slight projection with a curved, stuccoed-soffit, and flush verges have a moulded fascia. The residence is set on large grass and treed lot, and set back from the public sidewalk. An open metal fence with metal posts runs along the front of the property, and there is a large grassed side yard. The building is across the street from the former Miners' Union Hospital.

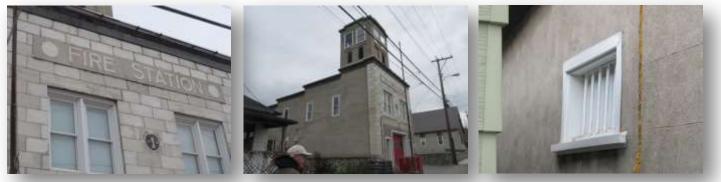
7625 18 AVENUE Coleman, Alberta

The Coleman Fire Station is a 1909 wooden two-storey structure faced with concrete block situated on three town lots just west of a main north-south route, and a block north of the downtown commercial district. The building has a centrally located door to accommodate the size of fire trucks of the period, and a square-shaped bell tower. An insignia carrying a 1934 date is located on the upper facade with a Fire Station sign integrated above, and a concrete Town Hall sign is integrated into the concrete block-faced town hall entry wing.

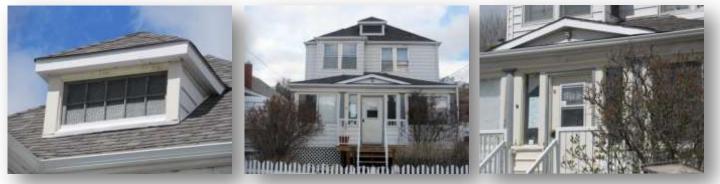
The Dr. Porter Residence is a simple c1926 square, two-storey, wood-frame, clapboard-sided building with a highgable roof, and a central hipped-dormer. A front enclosed front porch with tapered Doric columns carries a central low-pediment over a central entry flanked by sidelights. The site is located in a residential area just north of the former Miners' Union Hospital.

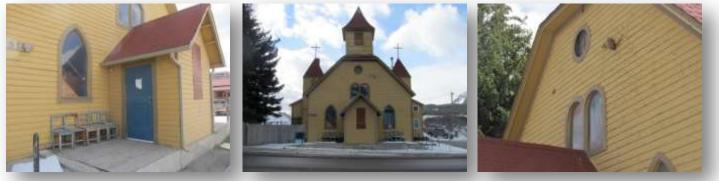
The Holy Ghost Catholic Church is a 1905, one-and-a-half storey structure with a high-pitched hipped-gable roof, and clad with wood clapboard siding. It contains a central bell tower with a scalloped pyramidal roof, an enclosed front porch, two smaller towers with pyramidal roofs on either side of the nave, and small extended wings on either side of the sanctuary. It is situated on Highway 3 just north of downtown Coleman.

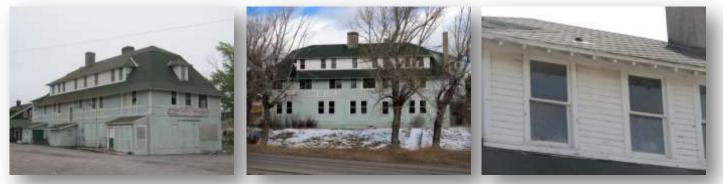
6601 20 AVENUE Coleman, Alberta

The McGillivray Mine Office is a 1909, two-and-one-half storey, large structure with a hipped gambrel roof, projecting eaves, and exposed rafters. The primary building is covered in stucco with horizontal wood banding detail. An elongated shed-like dormer on the front and rear terminate with a hip, and are covered with wood clapboard siding and corner boards. Numerous one-over-one, single-hung, wood windows create and extensive fenestration pattern on all sides. It building is situated on the north side of Highway 3 overlooking downtown Coleman.

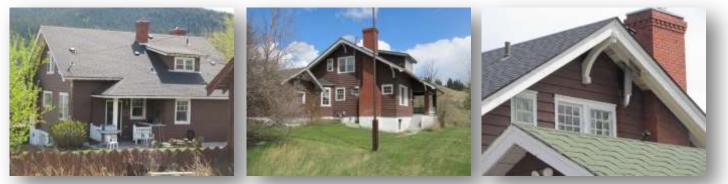
6605 20 AVENUE Coleman, Alberta

The McGillivray Mine Manager's Residence is a 1909, Craftsman-influenced, one-and-a-half storey, structure with wood clapboard siding, a low-gable roof with shed dormers, projecting eaves with exposed rafters, projecting verges with a curved termination and decorative, curved-wood brackets, and two corbelled-brick chimneys. An open front porch is supported with brick piers and enclosed by an open wood rail. The structure is situated on a grassed town lot with a vertical wood fence on the east, west, and north sides. The east side yard is terraced. To the rear of the property is the former McGillivray mine site. The former mine office is on the property to the west.

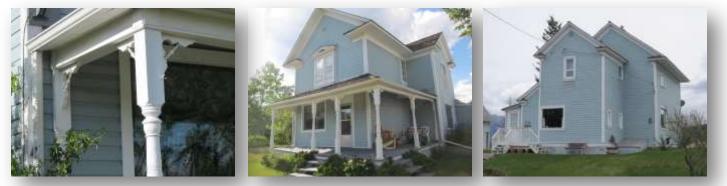
7714 22 AVENUE Coleman, Alberta

The Whiteside Residence is a 1905, two-storey building clad with wood shiplap siding and corner boards. It has a medium-gable roof with wood shingles, projecting eaves and verges with a moulded fascia, plain frieze and returned eaves, a gable dormer with returned eaves, and single-hung wood windows with lug sills. A wood pediment detail exists over second-storey windows on the south-side. An L-shaped, open verandah with decorated wood columns wraps around the south and east side. The residence is situated on a grassed town lot overlooking Coleman to the south. The front of the structure is towards the valley with the rear to the street.

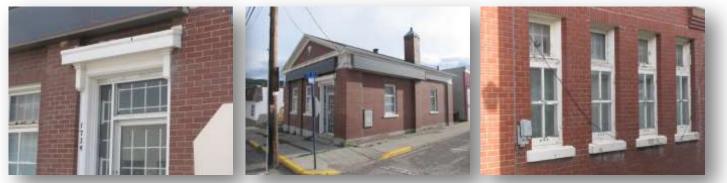
1734 77 STREET Coleman, Alberta

The Canadian Bank of Commerce building is a 1928, brick-clad, rectangular, single-storey structure with a mediumgable roof, located on a corner lot one block north of main commercial street. It carries a wood triangular pediment with a moulded architrave below that continues around the entire building.

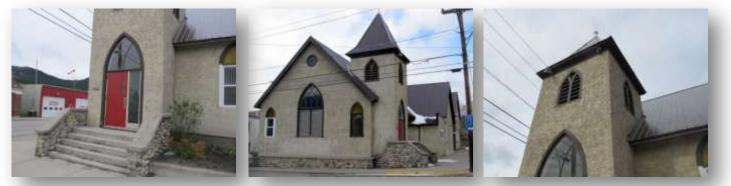
1802 77 STREET Coleman, Alberta

St. Paul's United Church is a 1906, one-storey, wood-frame, steep gable-roofed embellished with simple Gothic detailing in the form of pointed-arch fenestrations and a pyramidal-roofed bell tower over the main entrance. The church is situated near Coleman's main street.

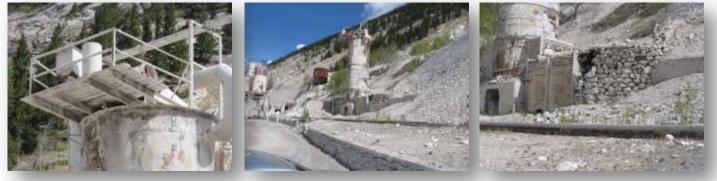
SE-7-8-5-W5 Coleman, Alberta

The Summit Lime Kiln is a 1905 lime processing structure with a central round vertical cylinder with metal rivets and metal strapping. It carries a wooden platform with an open railing, and is supported by a poured concrete base attached to several brick structures contained within a frame of angle iron. Each brick structure contains two ovens opening with fire brick arches. The kiln is located on the north-slope of a mountain, approximately 60-feet north of the Canadian Pacific Railway tracks, and a marked railway crossing.

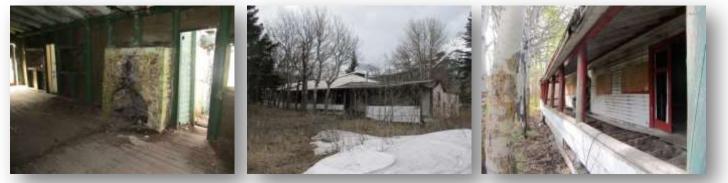
SE-9-8-5-W5 Coleman, Alberta

The Crowsnest Pass Dance Pavilion is a 1931, post-and-beam, one-storey structure with a pyramidal roof over the main structure, along with a rear wing with a shed roof and a side wing with a gable roof. An open verandah with a closed-railing, and with wide horizontal flush boards, extends the length of the facade and along the wing on west side. The main façade contains two main-entry two-panel, doors. The building is situated on the east shore of Crowsnest Lake, west of Coleman, and just north of Highway 3.
